VKF 250,000 Gallon Elevated Water Storage Tank Inspection Report

Arnold Air Force Base / AEDC
Tullahoma, Tennessee

May 10, 2002

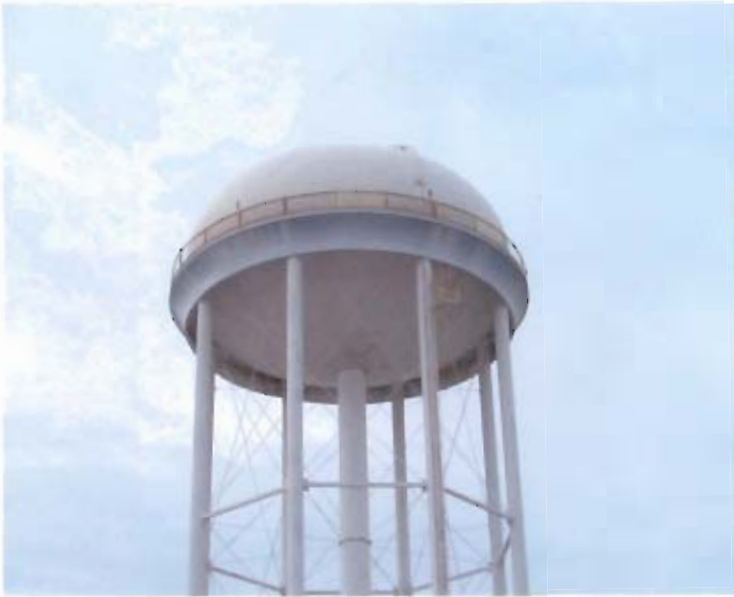
Top Left:

View of the exterior tank and structure from a distance.

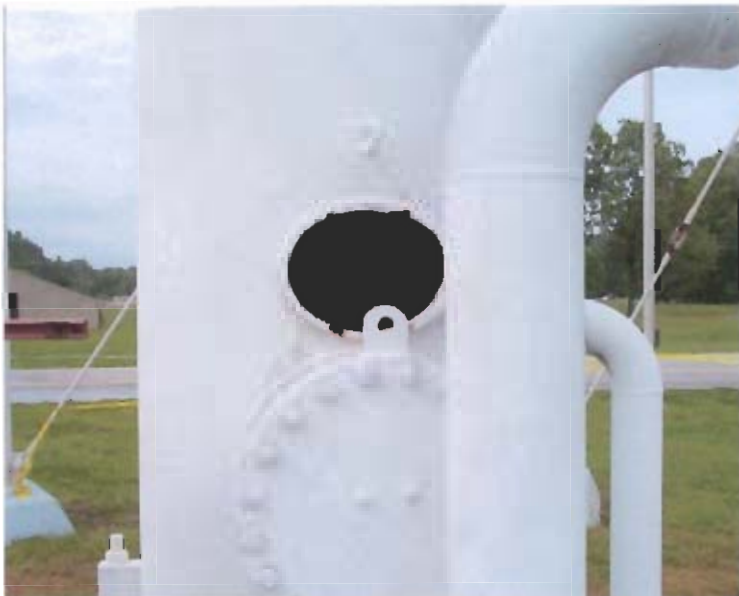
Top Left:

View of the riser with one of the access plates open for inspection.

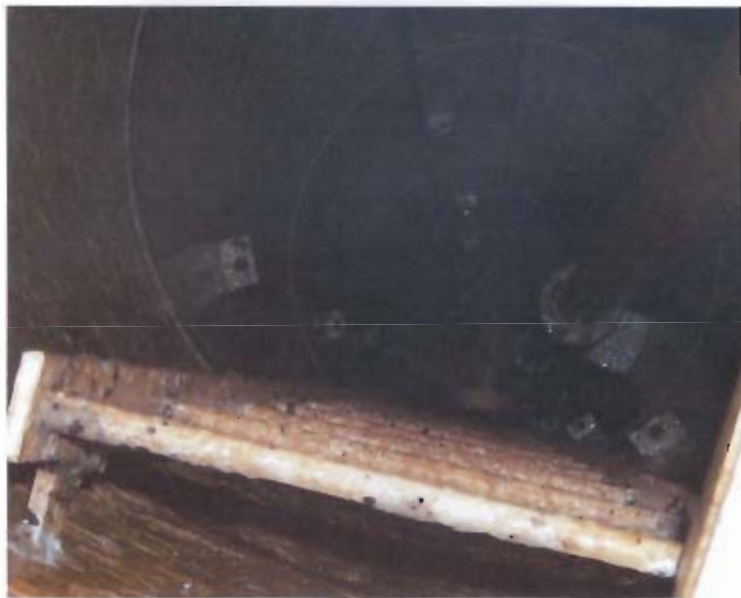
- Top Left:** Pitting from active electrolysis on the tank bowl.
- Top Right:** Rust and pitting in floor plates and weld seams.
- Bottom Left:** View of the riser from the tank bowl.
- Bottom Right:** Cathodic protection cables found on tank floor.

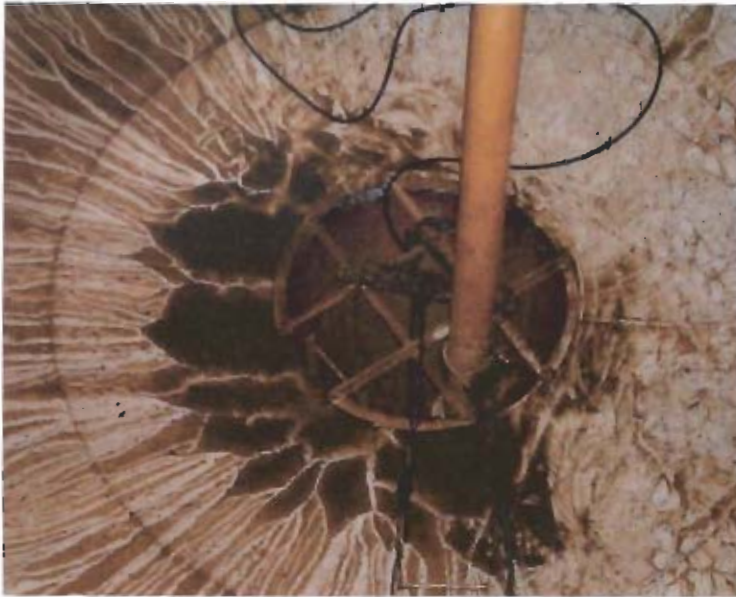
- Top Left:** Interior bowl at the riser showing riser safety grate in place. This photo was made prior to cleaning the sediment out.
- Top Right:** Eye level view of the spider assembly shows rusting.
- Bottom Left:** View of the spider assembly from the floor of the tank.
- Bottom Right:** Worker cleaning silt and sediment from the tank prior to the Inspection.
